**Subject: Visual Clearance Inspection Report Paint Removal for IPWP1**

**Site Address:** 3100 Airport Way S  
Seattle WA

**NVL Project #:** 2012-494

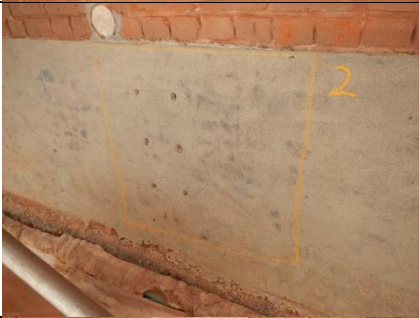
YES- Red paint on concrete near bottom of grid square.
3	361

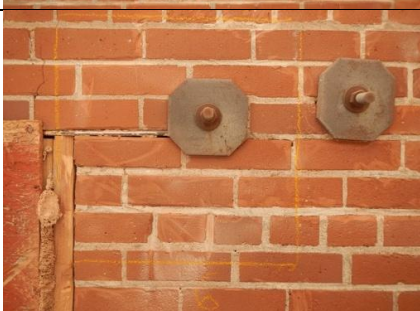
YES- red paint on wood 2x3 to left of grid square.
7	374

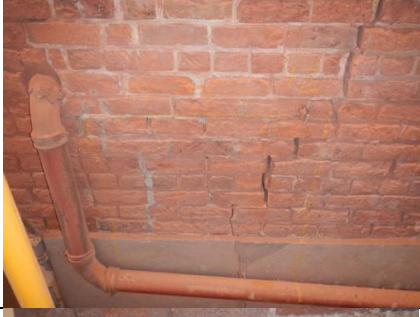
Yes- Red paint on and behind metal drain pipe.
15	468

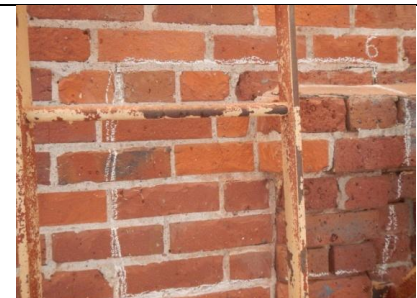
No

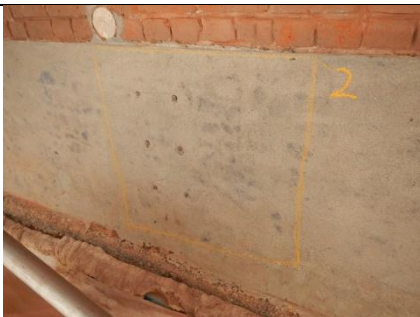
No
3	361

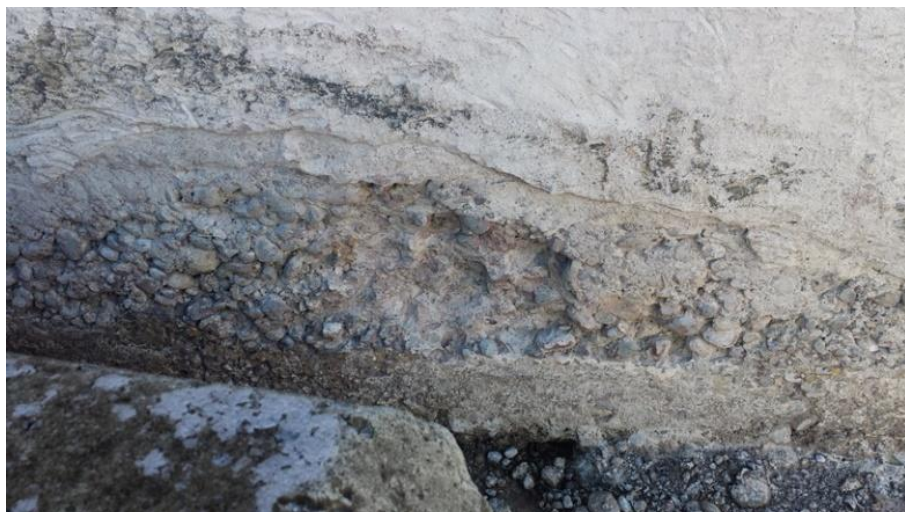
1. area of interest 1- bldg 13 north elevation NW corner

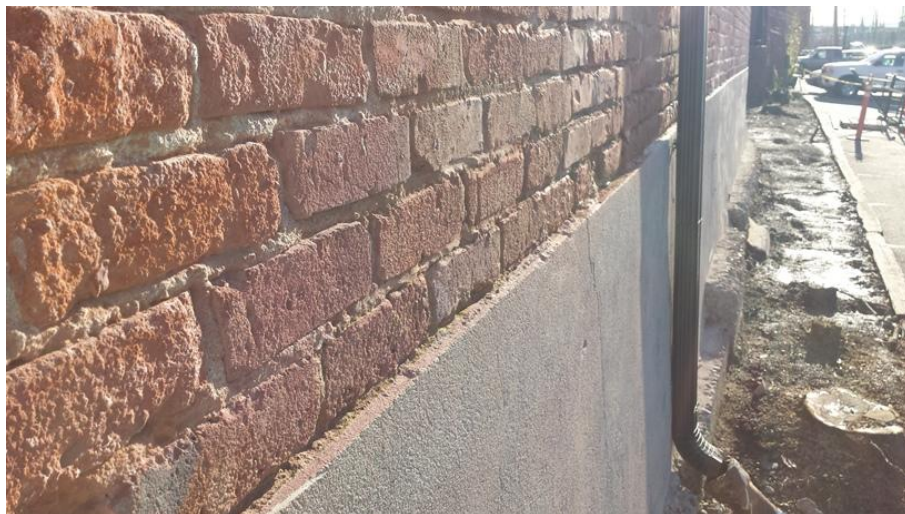
2. area of interest 2- bldg 13 west elevation NW corner

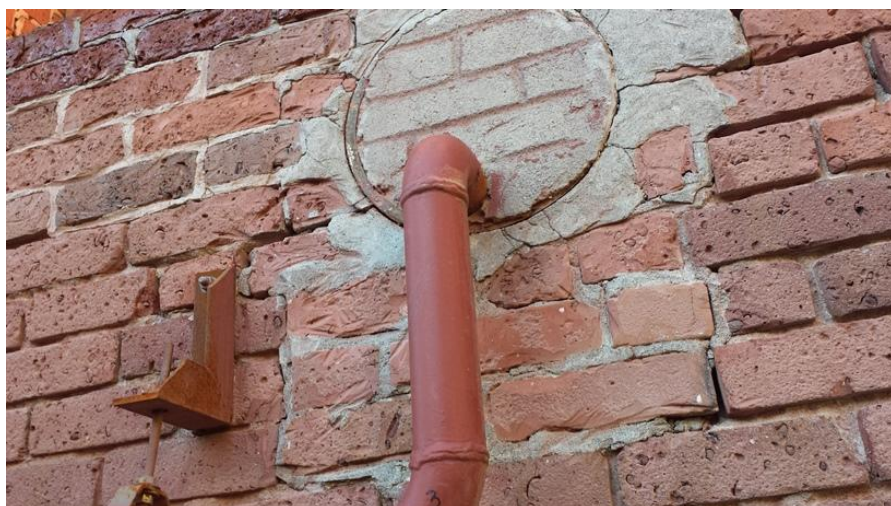
3. area of interest 3- bldg 13 south elevation SE

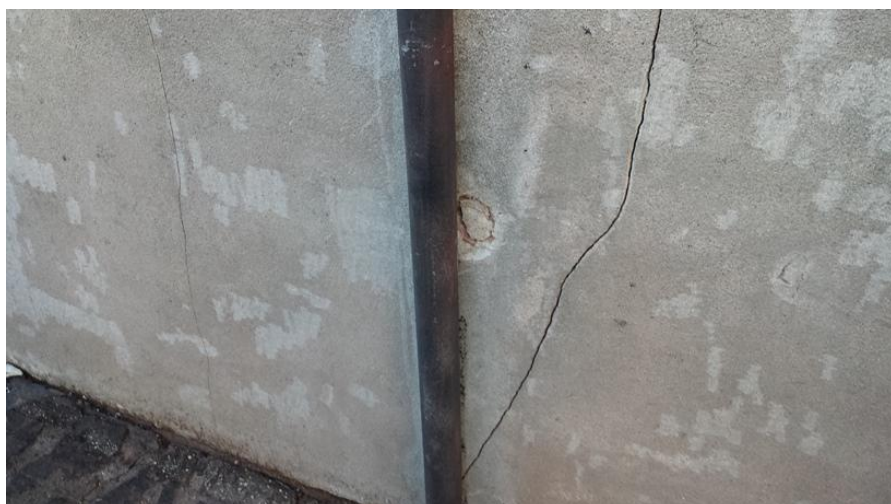
4. area of interest 4- bldg 13 south elevation SE

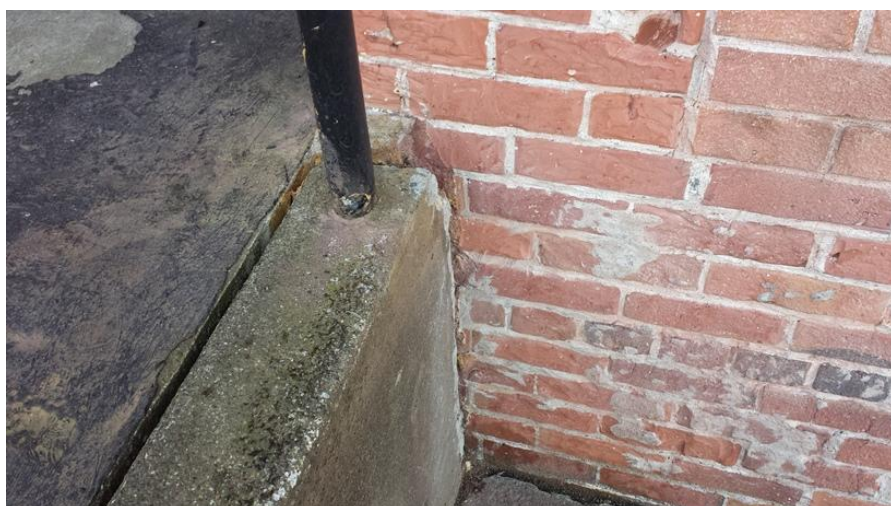
5. area of interest 5- bldg 13 North elevation

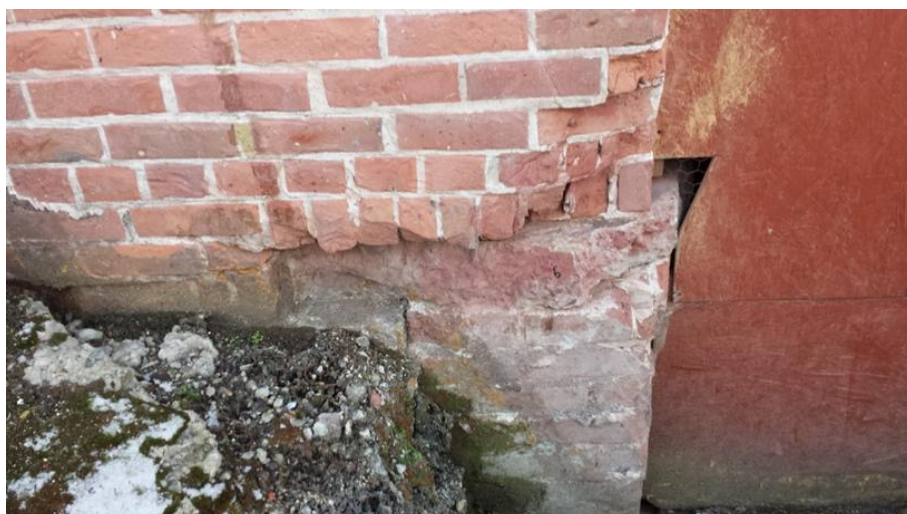
6. area of interest 6- bldg 13 north elevation

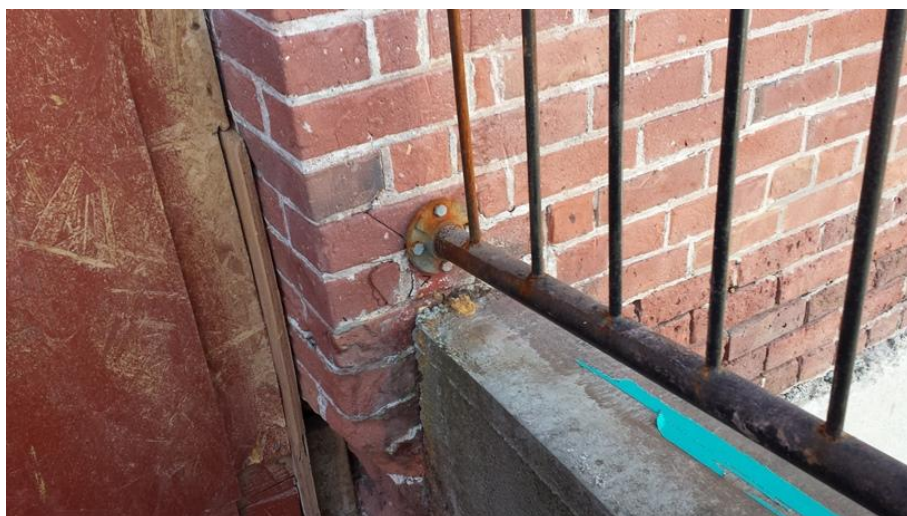
7. area of interest 7- bldg 13 north elevation

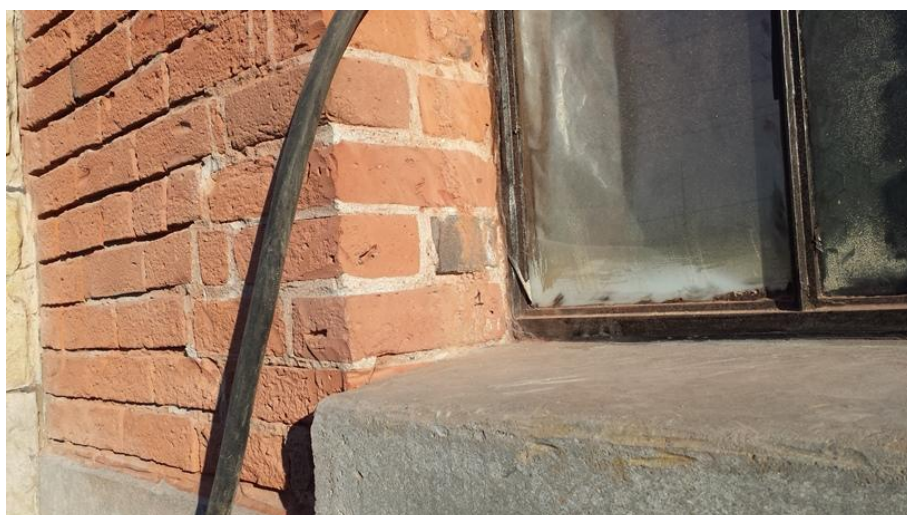
8. area of interest 8- bldg 11 west elevation

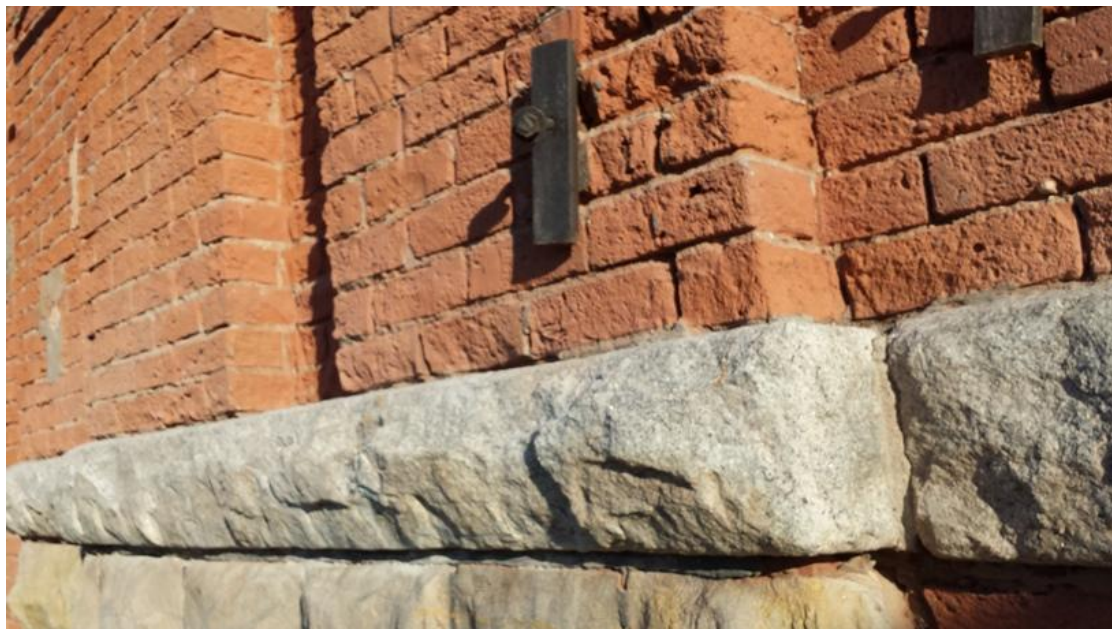
9. area of interest 9- bldg 11 west elevation

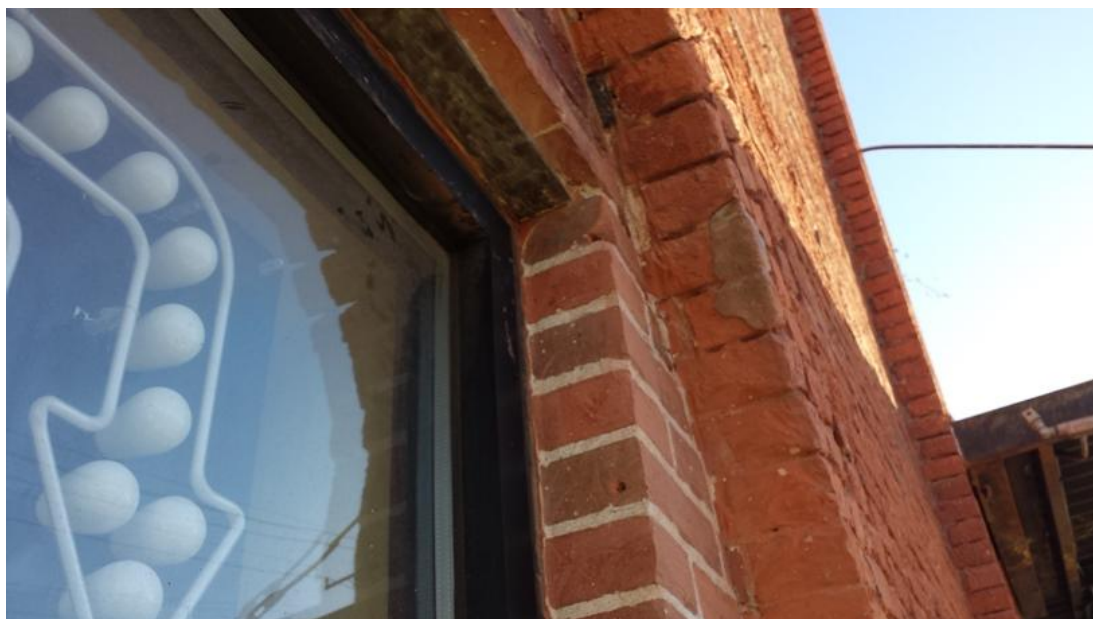
10. area of interest 10- bldg 11 west elevation

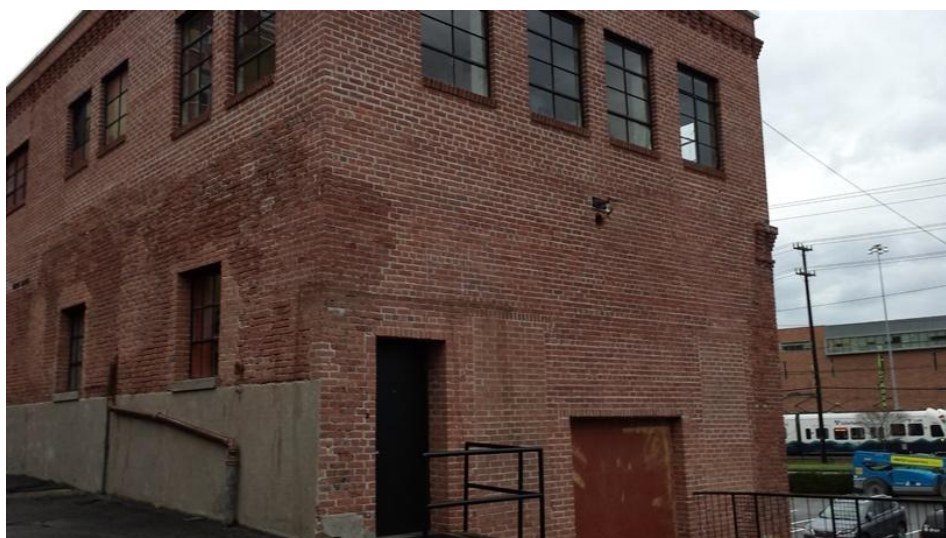
**Building 13  
North Elevation**

NVL found no visible paint remaining in any area inspected. No visible paint means standing and looking at the building at close range. The exception, within this no visible paint standard, was the observation of the occasional minute fleck of paint recessed into pits or cracks in the substrate, which were only observable at very close range. These exceptions were few and would have required hand removal with a dental pick or similar hand tool. Substrate sampling confirms that removal of more than 99 percent of the paint (no visible paint) results in PCB remedial waste at most, at 1.6 ppm in a single location (east wall building 13, concrete substrate), 1.1 ppm, the next highest result in one location (west wall building 11 sandstone substrate) and in all other locations (four additional concrete substrate samples) non-detect for PCBs<sup>3</sup>.
